Structure Number: 19
Original Use: Housekeeping Residence
Present Use: Personnel Quarters (duplex)
Construction Date: 1921
Architect: Unknown
Number of Levels: Three (including basement)
Total Area: 7,646 square feet
Plan Shape: Rectangular
Basic Construction: Wood frame
Uses per Floor: Basement

Structural Maintenance and Treatment Plan - Exterior Quarters

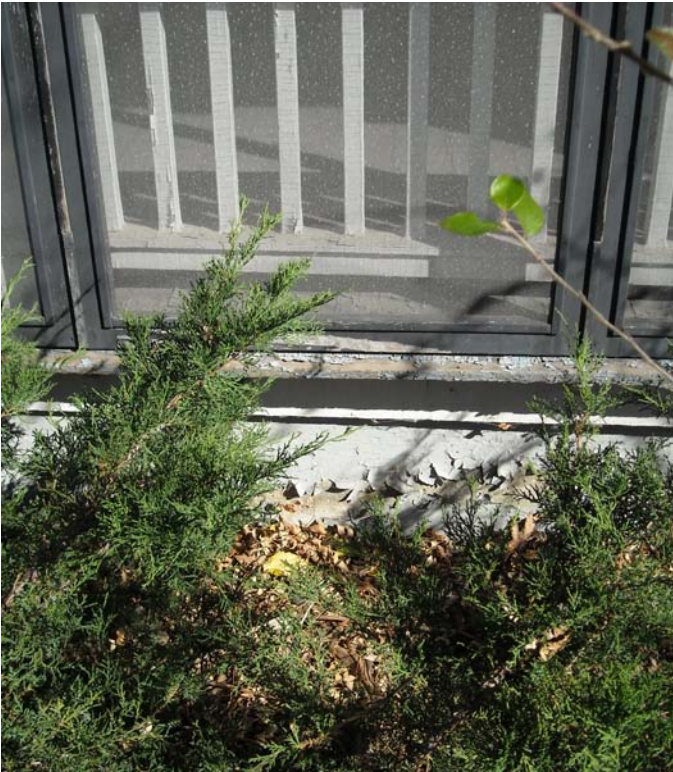
1 Peeling paint at concrete foundation wall and wood veranda.

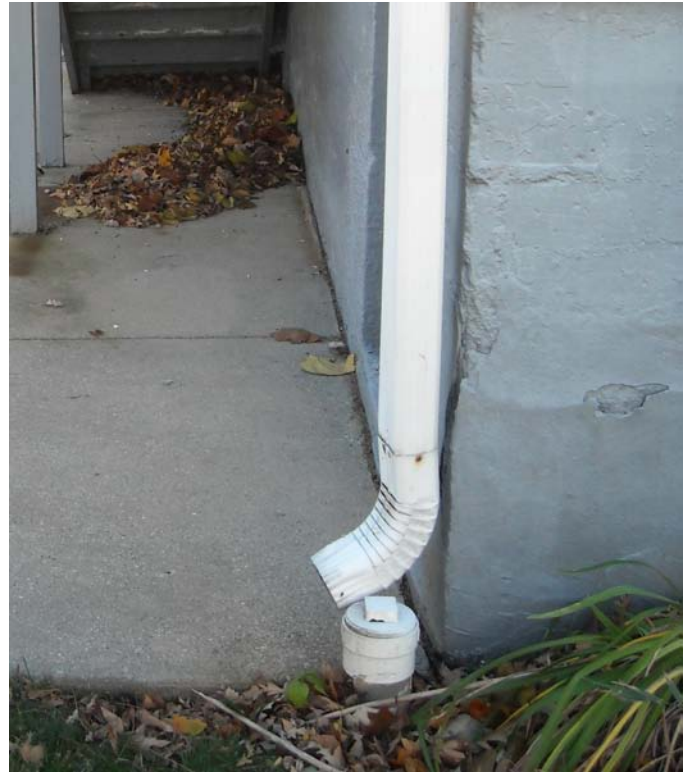
2 Spalled concrete foundation wall.

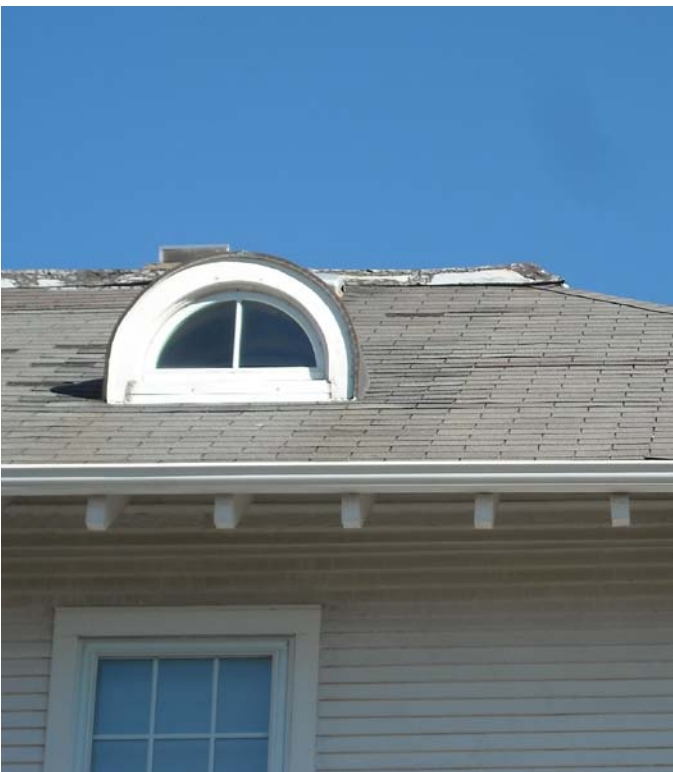
3 Dirt build up on wood clapboards; damaged asphalt shingles; flashing deterioration.

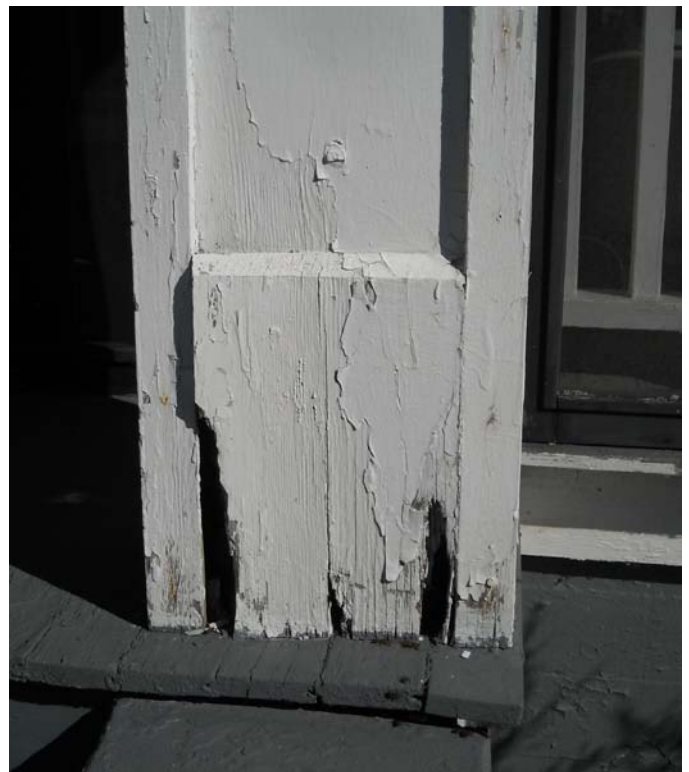
4 Deterioration at wood verandas.

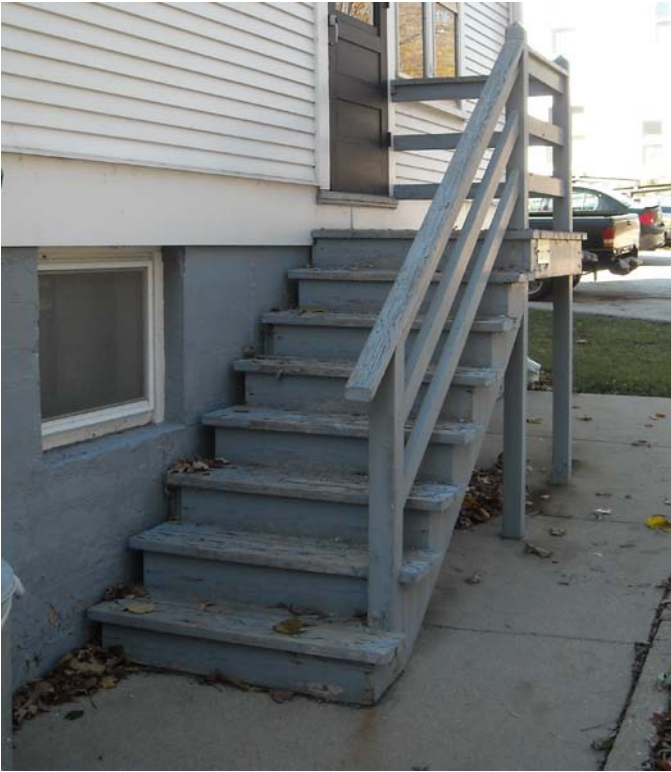
5 *Peeling paint and deterioration at wood verandas.*

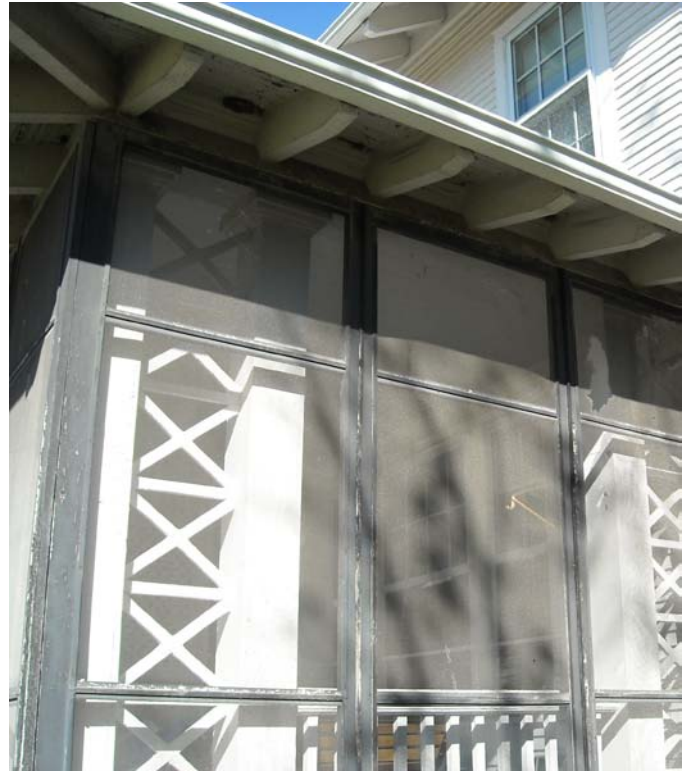
6 *Peeling paint and damaged screen at wood verandas.*

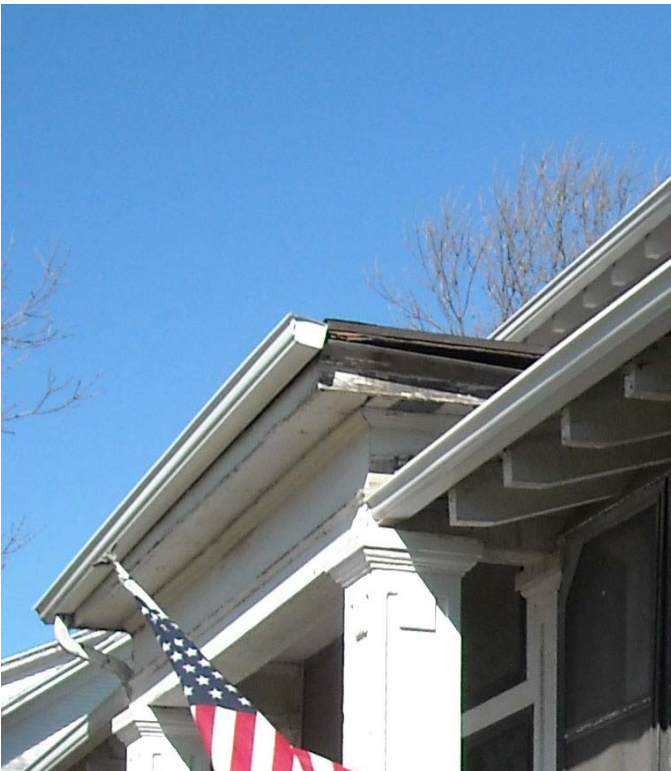
7 *Deterioration at fascia.*

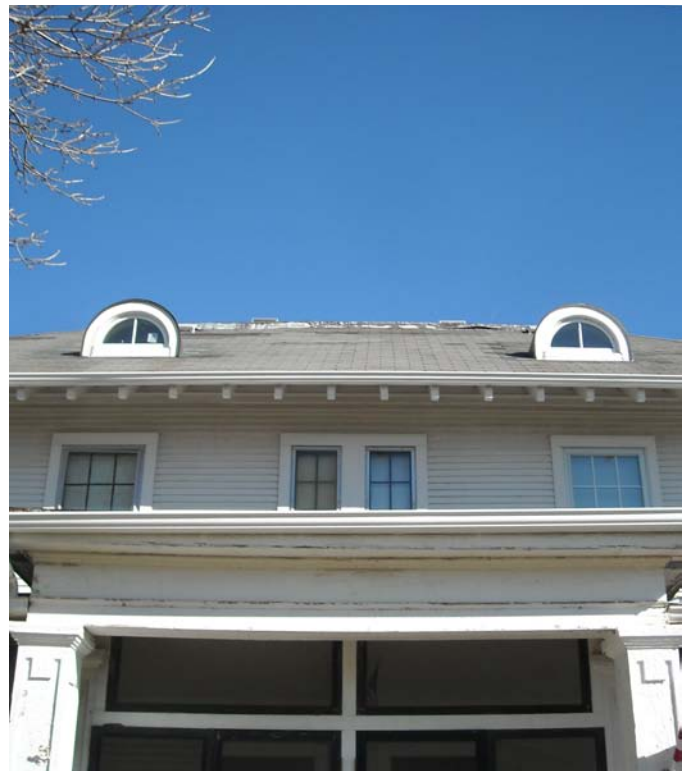
8 *Peeling paint at fascia; damaged asphalt shingles; flashing deterioration.*

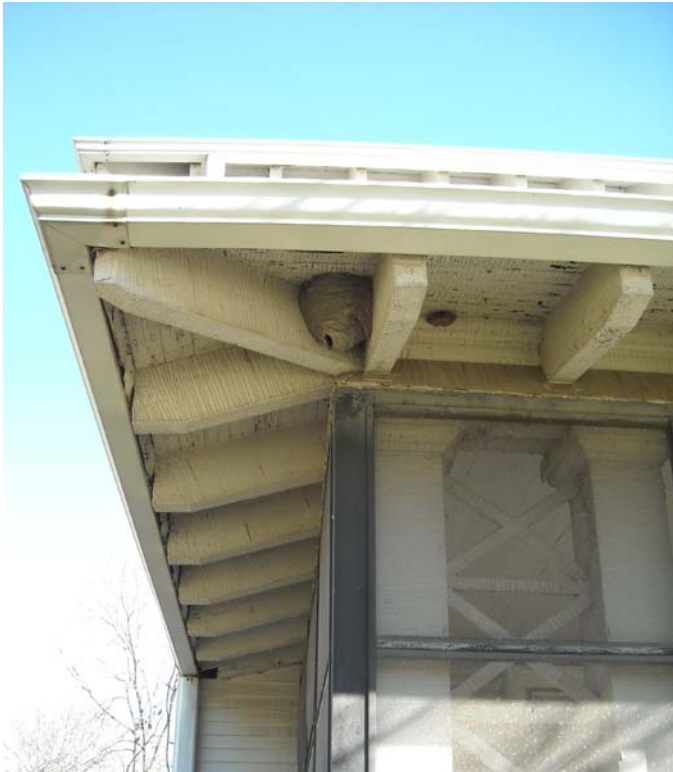
9 *Peeling paint at eaves.*

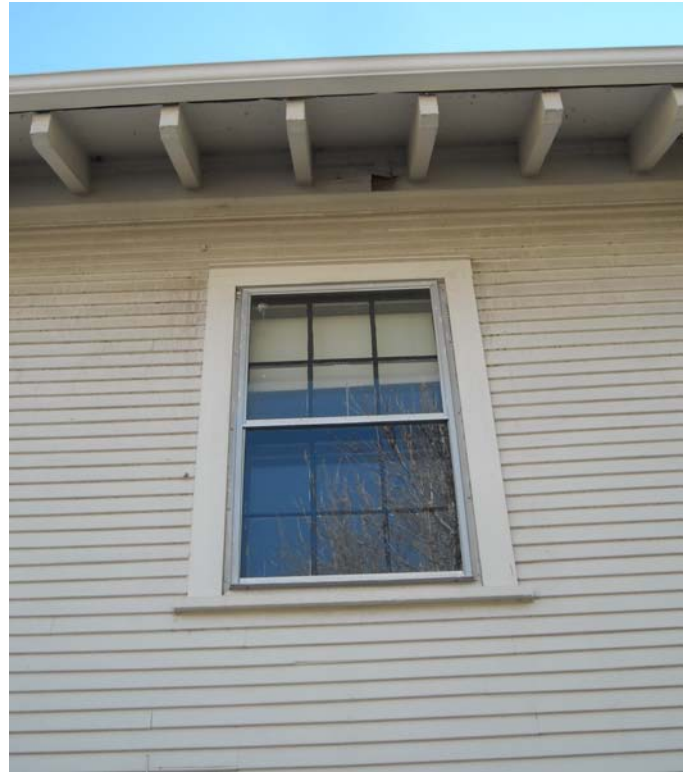
10 *Aluminum storm windows; deteriorating caulk; missing trim elements.*

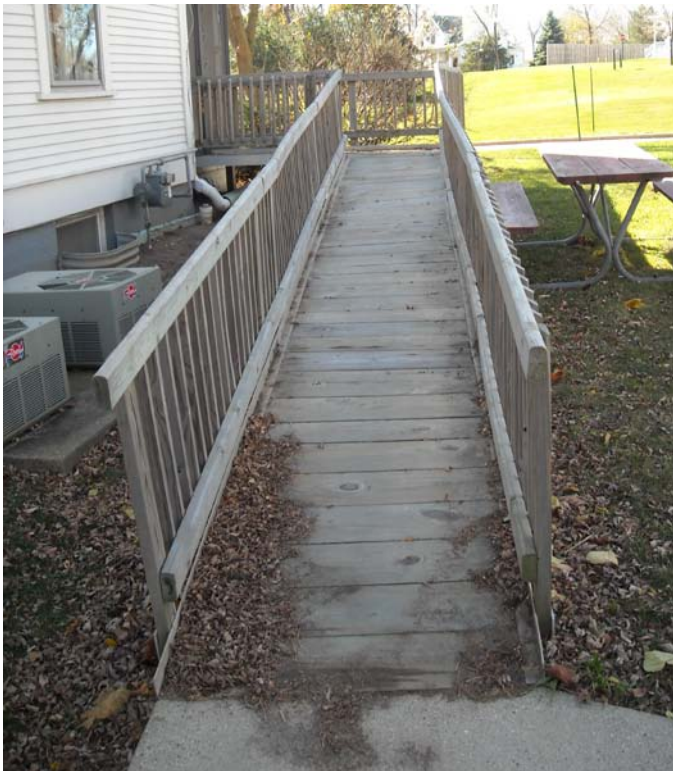
11 *Handicap access not compliant; unpainted material.*

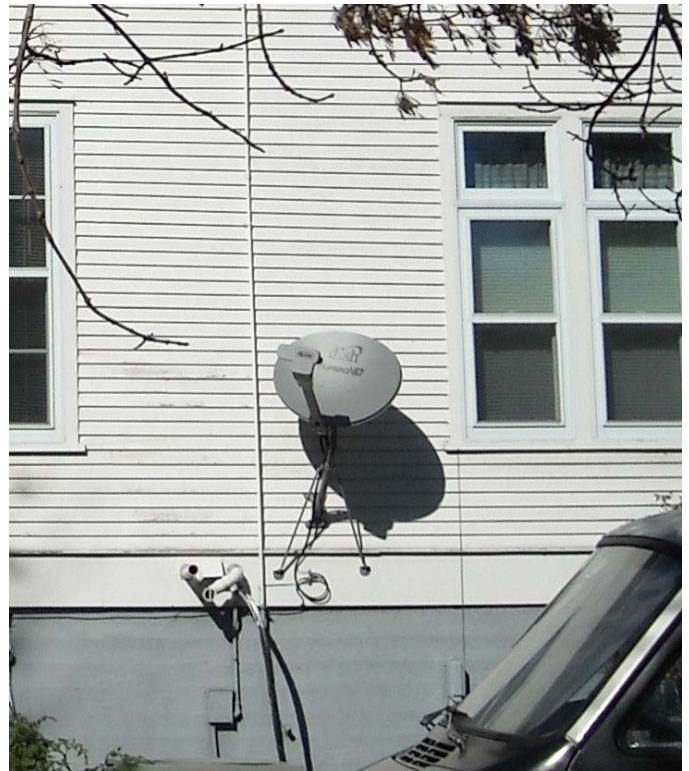
12 *Surface mounted equipment.*

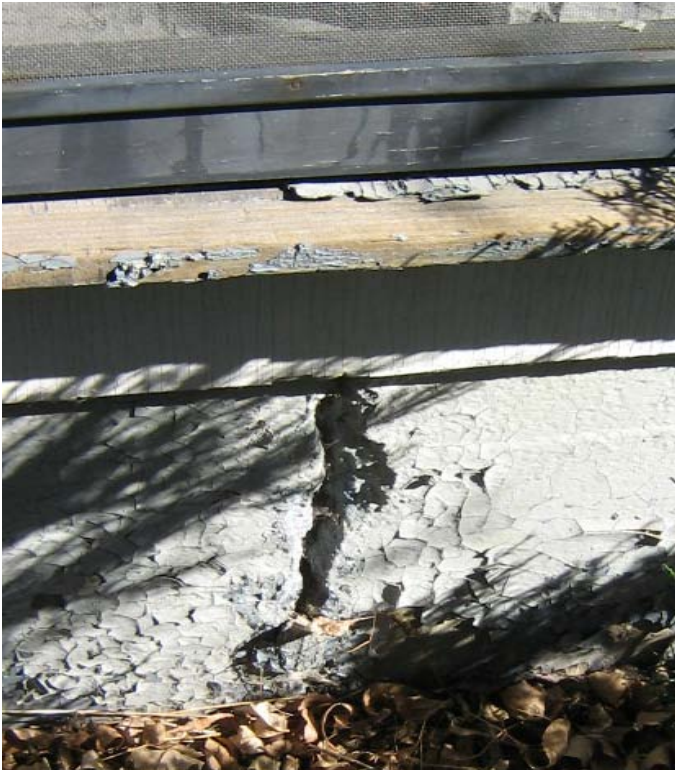
Minor cracking and surface deterioration is present on both the exterior & interior faces of the foundation walls. There was also minor structural deterioration found for many of the interior masonry piers. More significant cracking and surface deterioration was at the foundation walls at the (1) exterior patio location.

Photo 1: Deterioration & Cracking at Existing Concrete Foundation Walls.

Repair of all existing concrete foundation walls where cracking and deterioration has occurred should be addressed in the near future. Cleaning & removal of the surface deterioration that is currently present would also be recommended.

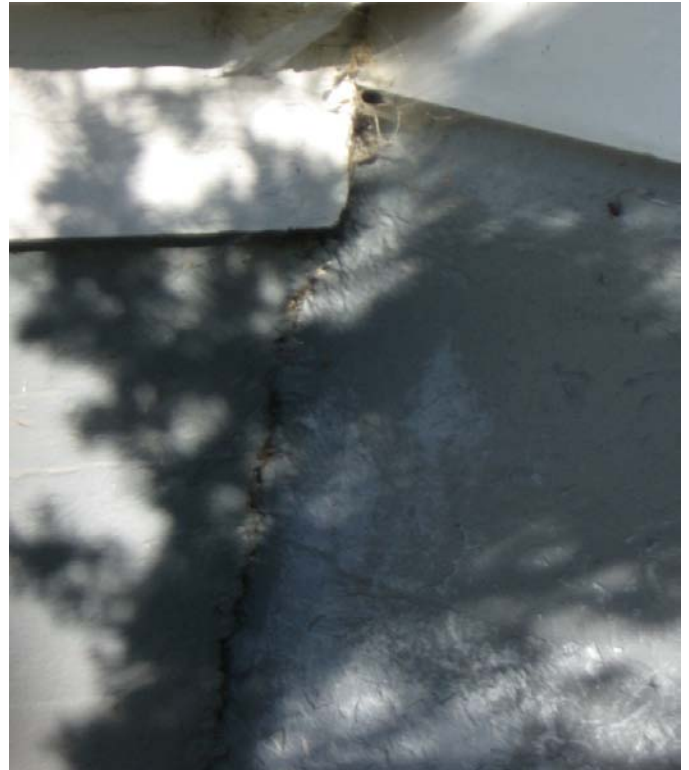
Photo 2: Deterioration & Cracking at Existing Concrete Foundation Walls.

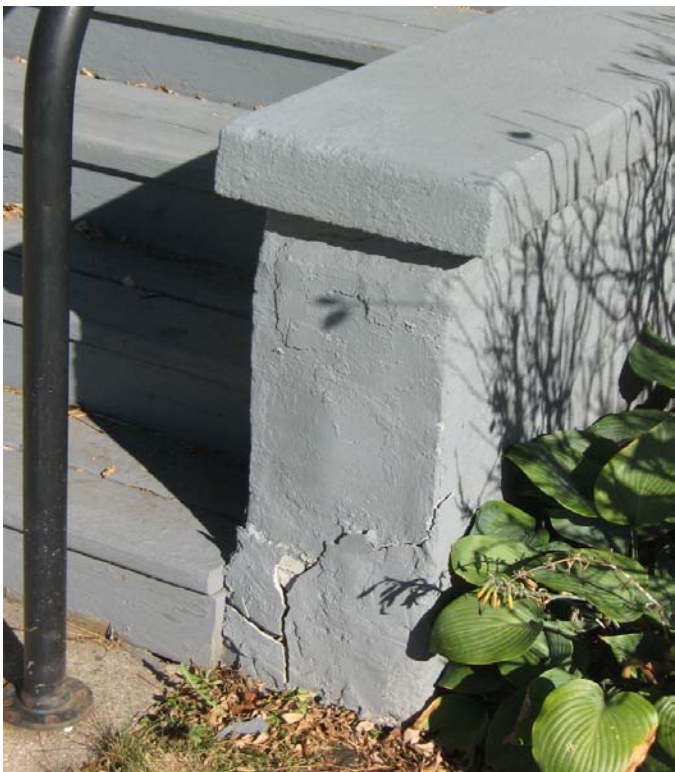
Photo 3: Deterioration & Cracking at Existing Concrete Foundation Walls.

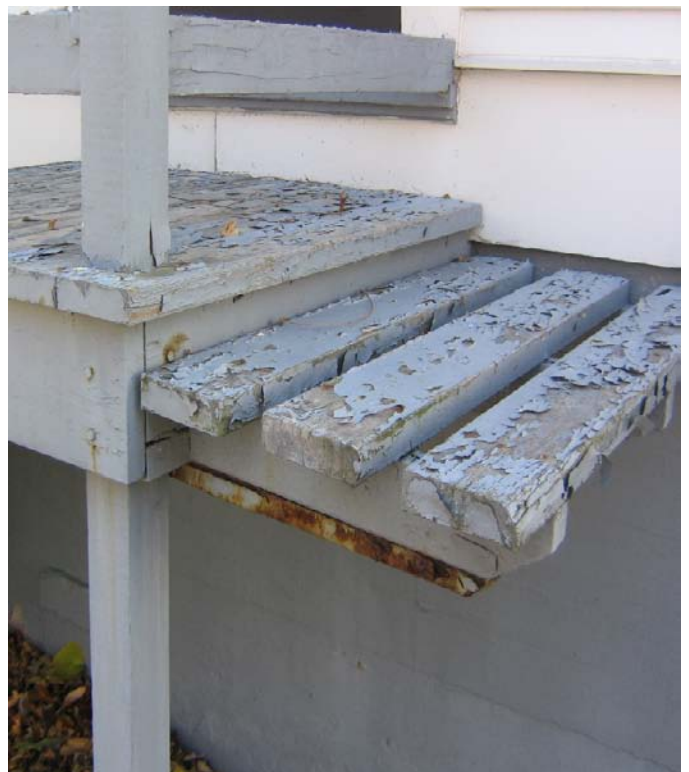
Photo 4: Deterioration of Exterior Wood Stair & Associated Framing.

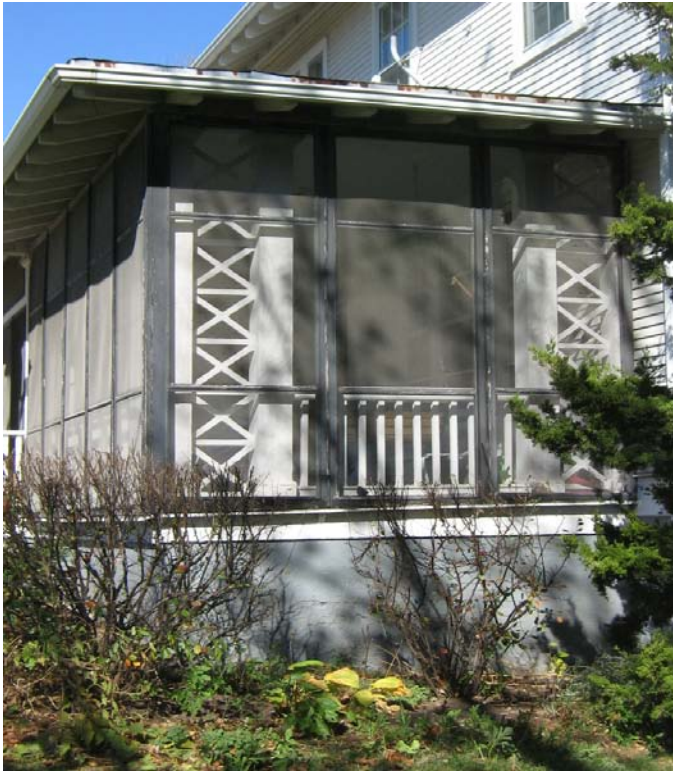
In addition to the deficiencies noted above, there is one other area of more significant concern in regards to the First Floor framing. The floor framing associated with the exterior patio has experienced significant structural deflection & differential movement. This has caused noticeable sagging and warping of the finished floor surface. This is likely the result of the cracking and deteriorating foundation walls below.

Photo 5: Deterioration & Warping of Existing Exterior Patio.

In regards to the floor construction associated with the (1) covered exterior patio where noticeable structural deflection differential movement has begun to take place; further structural analysis is advised to help determine the extent and type of repairs needed. Temporary structural shoring along with new foundation walls may be required at this location in order to prevent further structural deterioration to the floor construction above.

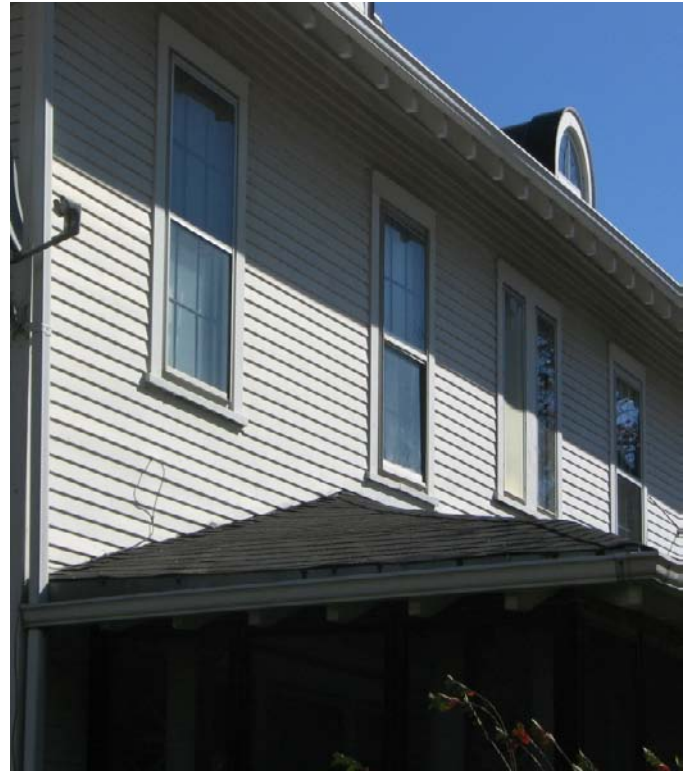
Roof framing associated with exterior patio was found to be in 'good' condition. In this instance, there are some signs of some minor structural deflection to the roof construction and supporting structure, as a noticeable 'belly' is visible from the exterior.

Photo 6: Deterioration & Warping of Existing Patio Roof.

In regards to the roof construction associated with exterior patio where noticeable structural deflection has occurred, further structural analysis is advised to help determine the extent and type of repairs needed. Structural shoring and additional roof framing may be required to prevent further structural damage.

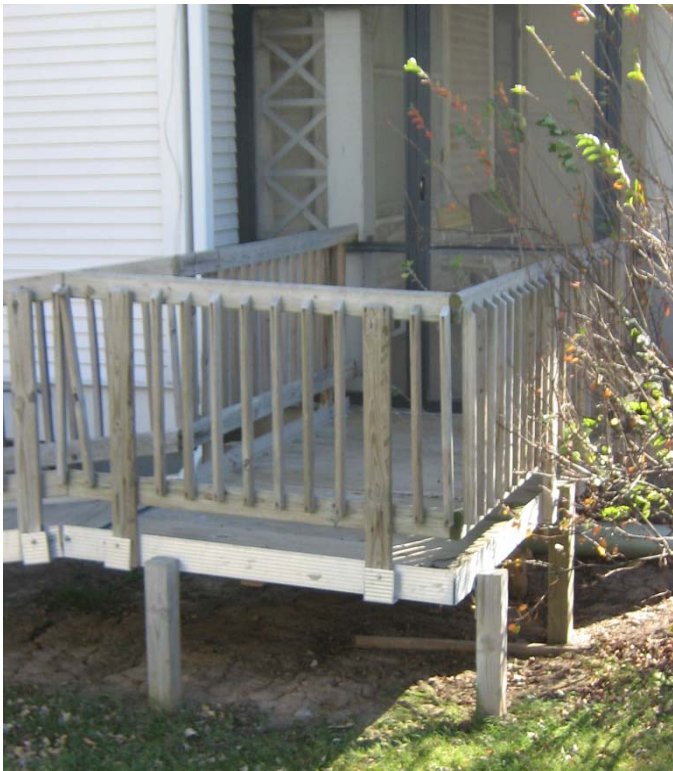
Photo 7: Deterioration & Warping of Building Ramp & Associated Framing.

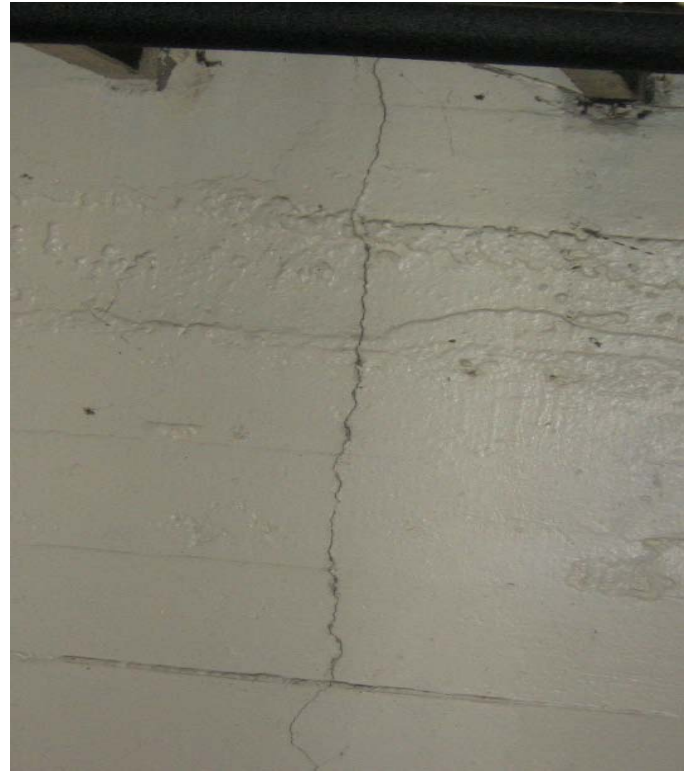
Photo 8: Deterioration & Cracking at Existing Concrete Foundation Walls.

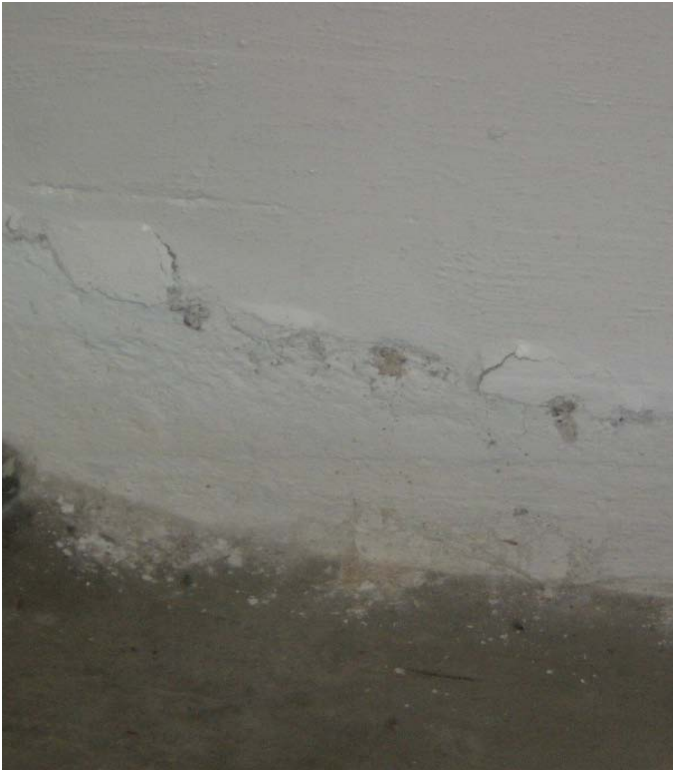
Photo 9: Deterioration & Cracking at Existing Concrete Foundation Walls.

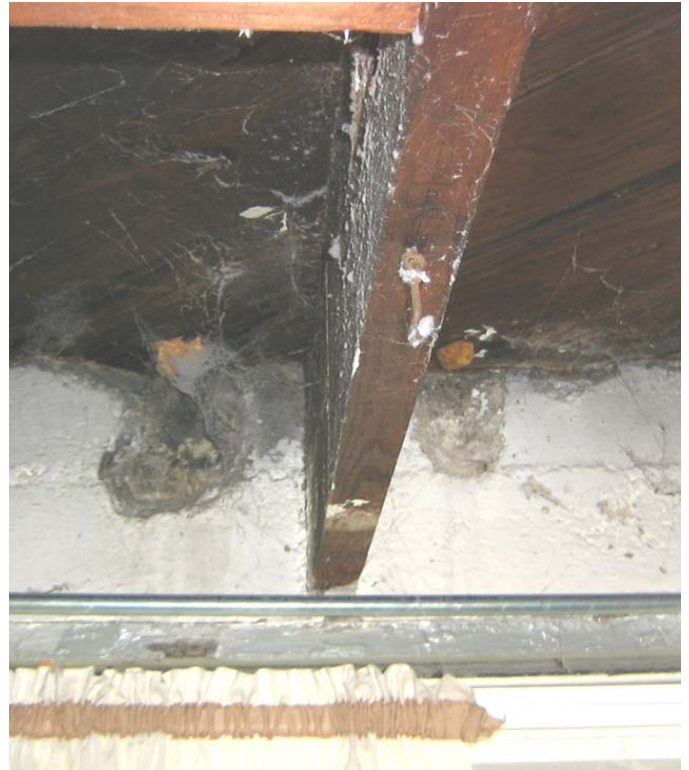
Photo 10: Deterioration & Cracking at Existing Concrete Foundation Walls.

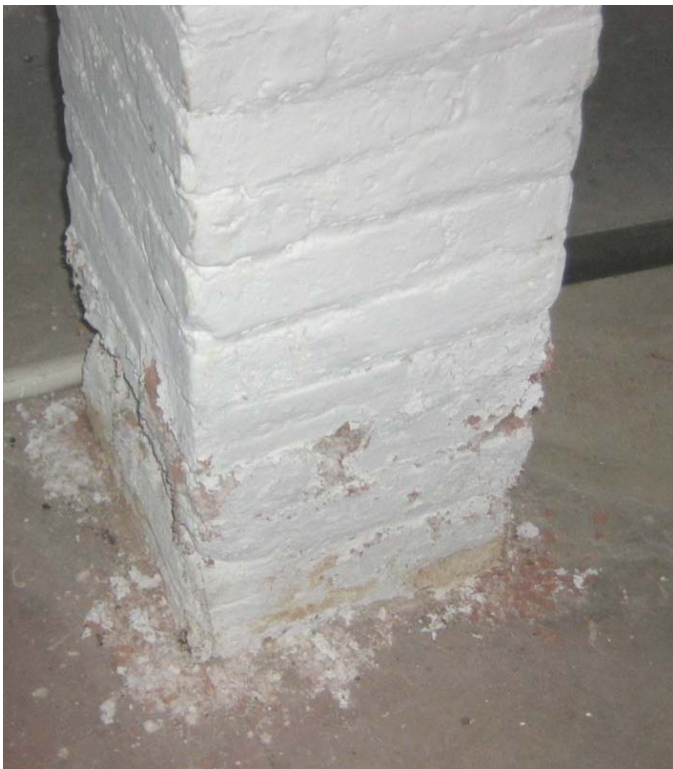
Photo 11: Deterioration & Cracking at Existing Interior Masonry Column.

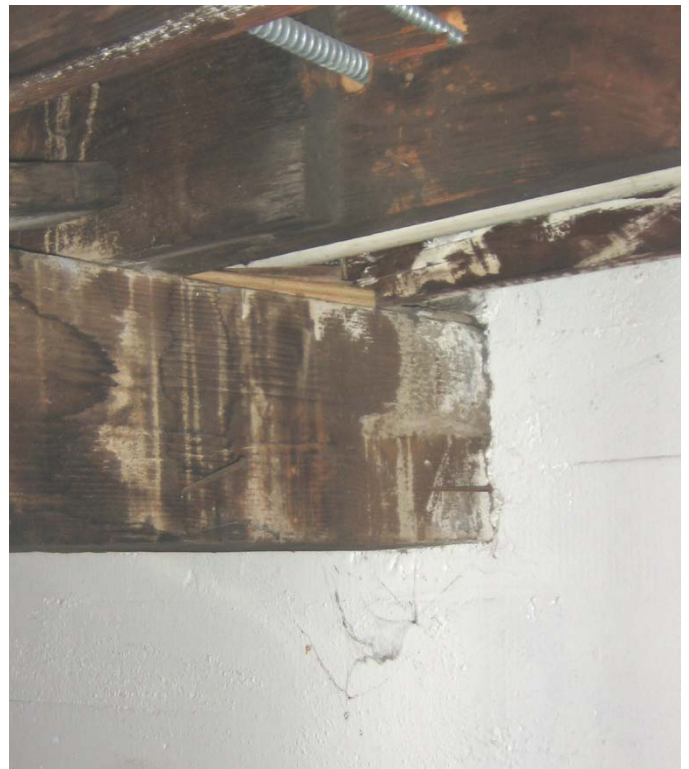
In regards to the main First Floor framing that has been left fully exposed & is readily visible from the basement, there is some evidence of moisture damage & surface deterioration as evidence by the discoloration of the exposed wood floor joists and associated framing. More importantly however, moderate cracking & structural deterioration was found in some of the intermediate wood floor beams.

Photo 12: Deterioration of Existing Wood Beam & Associated Floor Framing.

In general it is recommended that all structurally solid exposed interior and exterior wood framing members be cleaned and refinished to prevent further weathering and surface deterioration.

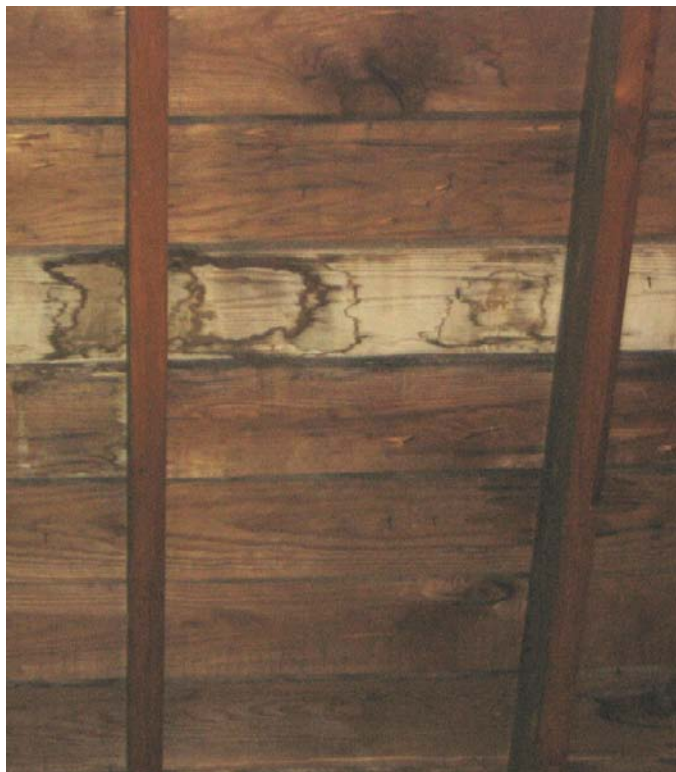
Photo 13: Deterioration of Existing Wood Roof Framing & Associated Roof Boards.

In general it is recommended that all exposed interior & exterior wood roof framing be cleaned and refinished to prevent further weathering and deterioration. Wood members that are structurally compromised should be replaced.

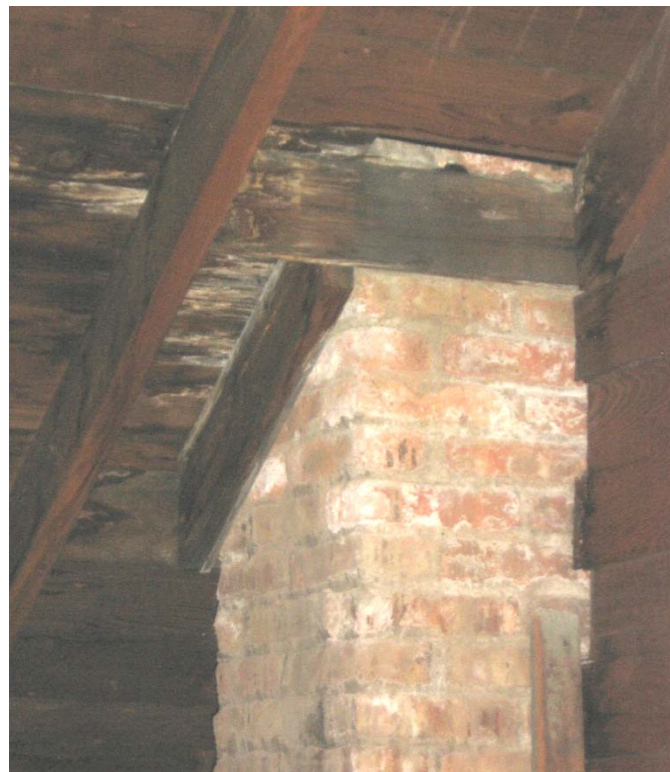
Photo 14: Deterioration of Existing Brick Chimney Stack, Wood Roof Framing, & Roof Boards.

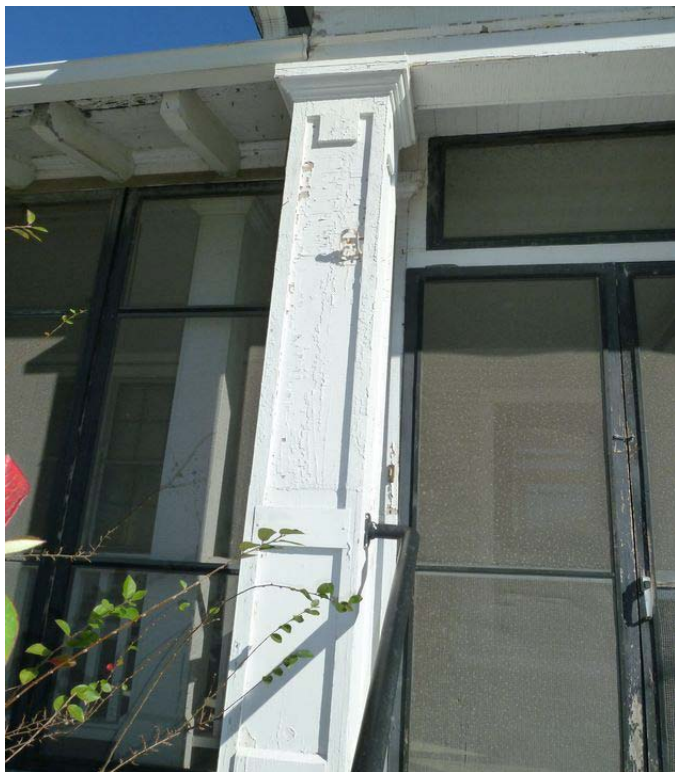
1 Paint peeling on eaves and column.

Paint which has begun to peel due to a failure of the bond to the wood, plaster, or metal substrate should be removed. Paint is best removed with the careful use of metal scrapers. Sanding is usually required to eliminate rough surfaces and to smooth the transition between areas of raw wood and solid original painted surfaces. Before repainting, all raw surfaces should be primed with a tested and approved primer. This treatment should then be followed by required coat(s) of paint of the type and color to match the surrounding area. All activities must be conducted in a manner consistent with the requirements provided in 29 CFR 1926.

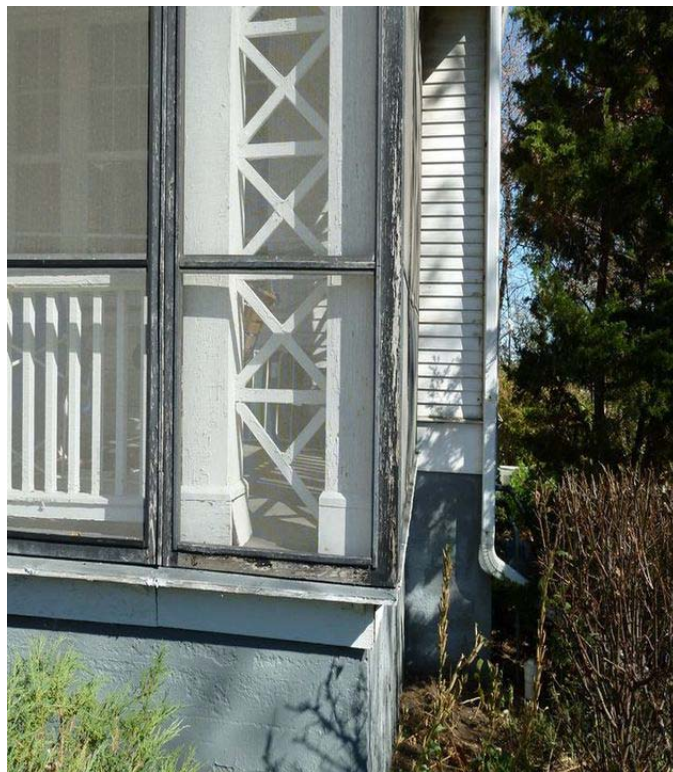
2 Paint peeling on wood porch framing.

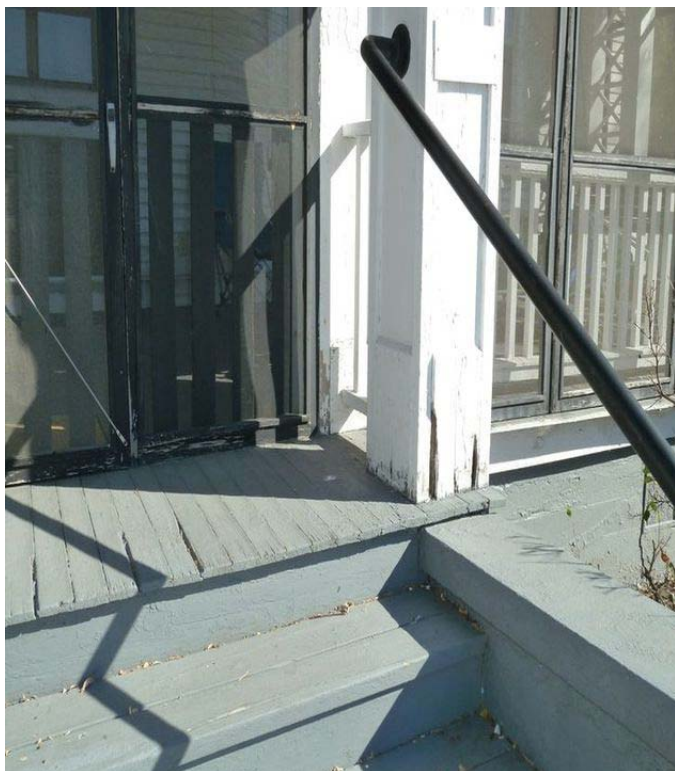
3 Peeling paint on door.

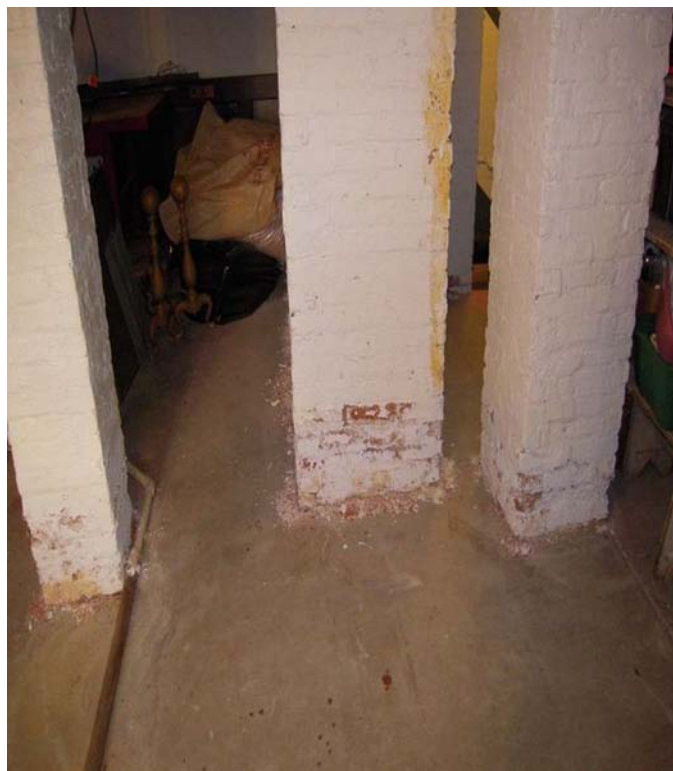
The interior brick and mortar foundation is showing signs of spalling/deterioration along the base of the floor and approximately two feet along the perimeter of the basement and on support columns. The spalled/deteriorated brick and mortar should be repaired or replaced. Plaster damage is evident in the attic around the chimney and should be repaired. A few cracked ceramic wall tiles were observed in the bathroom of the north unit and should be repaired or replaced. See the **'Hazardous Materials Maintenance Treatment Plan - Exterior'** and **'Hazardous Materials Maintenance Treatment Plan - Interior'** for locations of affected areas noted above. All activities involving asbestos or materials assumed to contain asbestos should be conducted in accordance with all local, state and federal rules and regulations.

4 Spalling brick and mortar in basement.

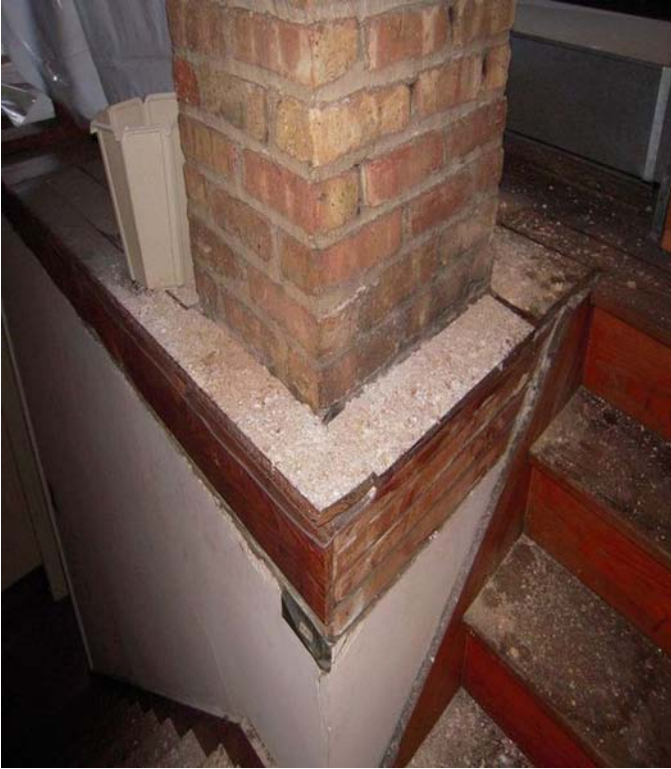
5 *Deteriorating plaster from area above chimney.*

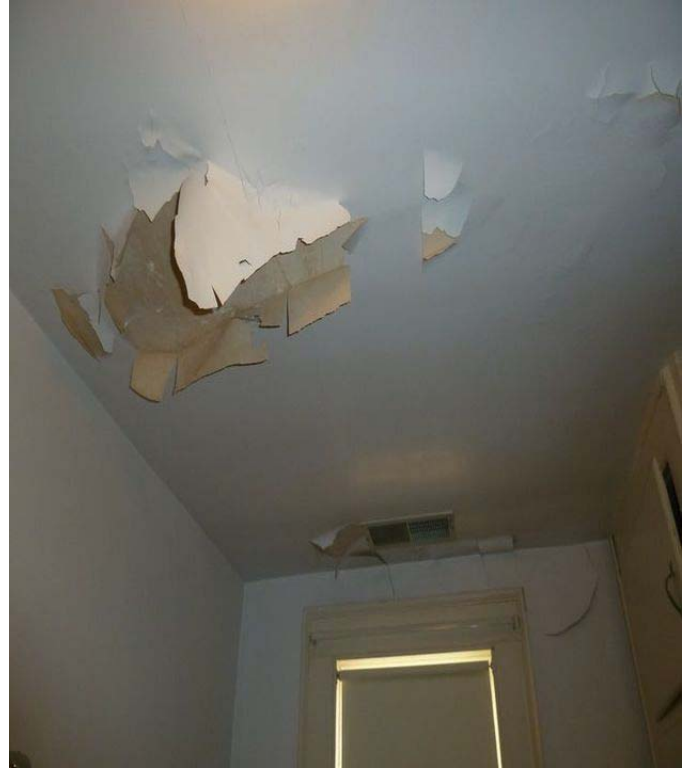
6 *Peeling paint on ceiling and walls.*

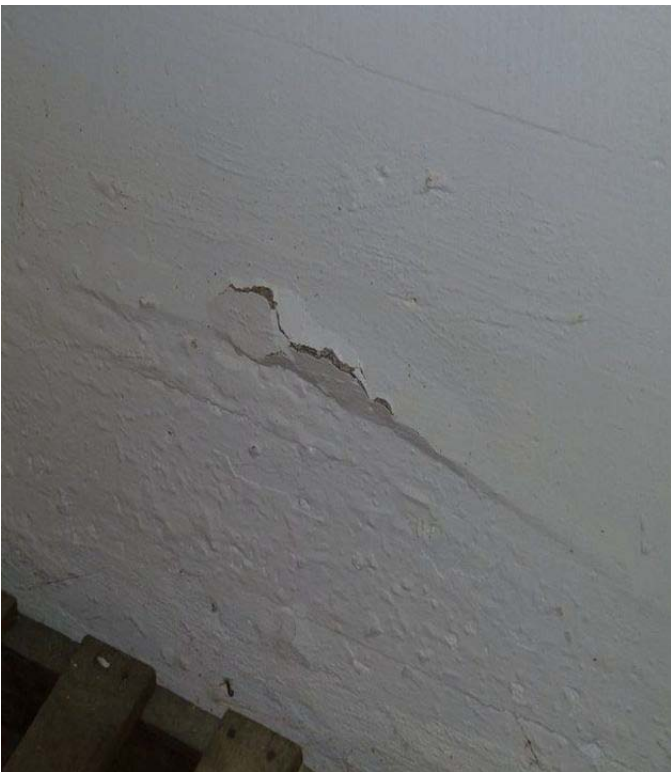
7 *Peeling paint on wall.*

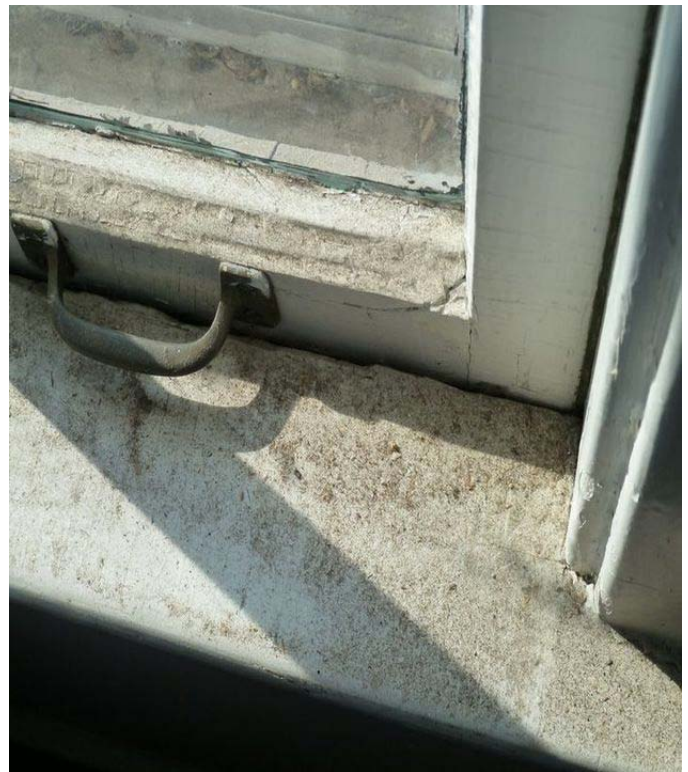
Suspect visible mold growth was visually observed on window sills on the second floor bedrooms on the north side of the building. See the **'Hazardous Materials Maintenance Treatment Plan - Exterior'** and **'Hazardous Materials Maintenance Treatment Plan - Interior'** for locations of affected areas noted above.

8 *Suspect mold growth on window frame.*

Suspect mold growth and stained building materials implies that there is or has been water intrusion or leaks or the relative humidity within the building was high enough to cause localized or widespread condensation. It is recommended that the moisture source be located and corrected, if this has not already taken place, remove fungal-impacted building materials, and replace or repair the water stained materials.

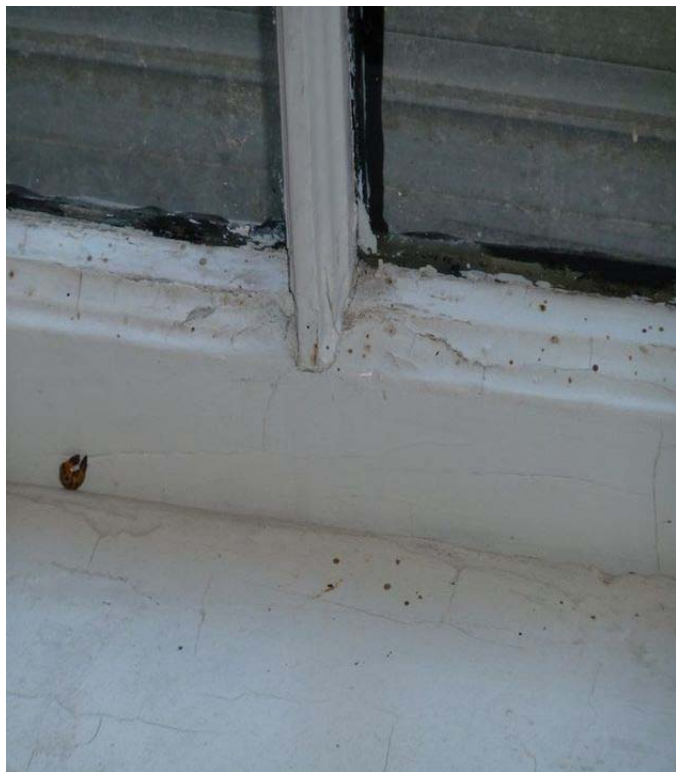
9 *Suspect mold growth on window frame.*

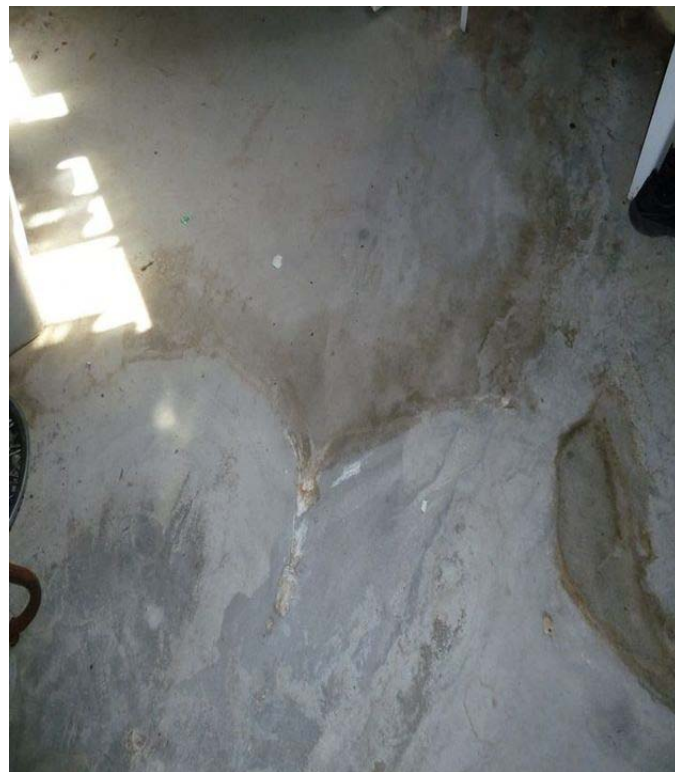
10 *Discoloration on basement floor.*
